Kamil TITZ, Kateřina KONEČNÁ, Miroslav TVRDÝ¹

SURFACE SPOTS ON PLATE OF ALUMINIUM ALLOY

¹ *Metallurgical and Material Engineering Faculty, VŠB – TU Ostrava, Czech Republic*

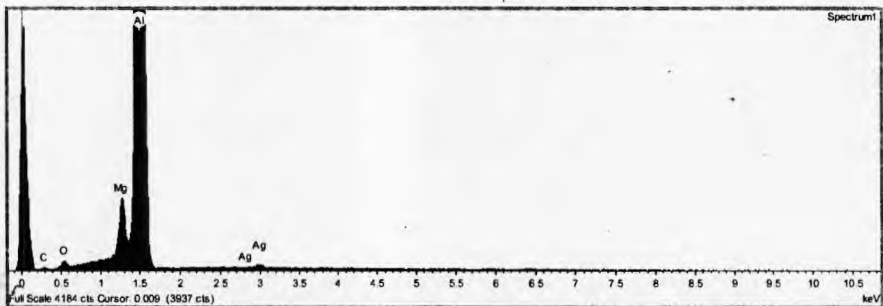
Fig. 4 Spot where the local chemical analysis has been taken

The surface chemical analysis is shown in the Figs. 4 and 5 (for the samples 1 and 2) and in the Fig. 6 for the reference sample 3. On the basis of the detailed chemical analysis it is not possible to decide about the spot origin.

Name	Weight %			
	O	Mg	Al	Ag
Spectrum1	3.332	3.148	92.532	0.987
Spectrum2	3.064	3.101	93.110	0.725
Spectrum3	3.672	3.120	91.660	1.547
Spectrum4	6.037	3.177	89.244	1.541
Spectrum5	6.885	3.115	88.552	1.448
Spectrum6	5.533	3.080	89.844	1.542

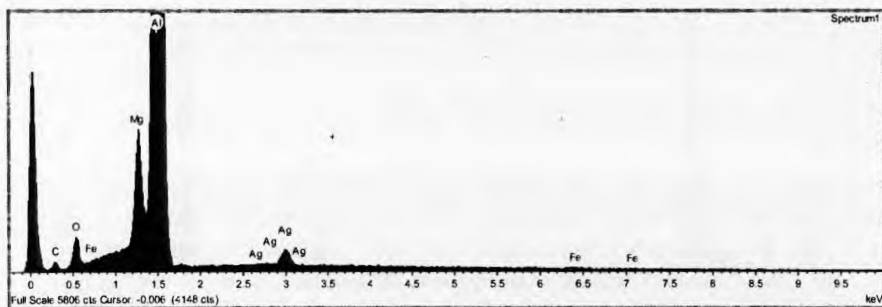
Fig. 5 Spot where the chemical analysis has been taken

Name	Weight %				
	O	Mg	Al	Fe	Ag
Spectrum1	7.035	3.269	87.005	0.239	2.452
Spectrum2	6.844	3.239	87.200	0.250	2.468
Spectrum3	6.975	3.183	87.089	0.234	2.520
Spectrum4	5.650	3.210	88.461		2.679
Spectrum5	6.259	3.189	88.093		2.458
Spectrum6	6.007	3.223	88.698		2.071

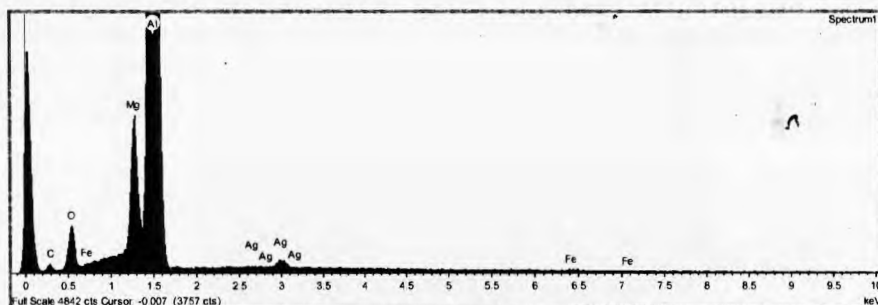
Fig. 6 Spot where the chemical analysis has been taken

Name	Weight %						
	O	Mg	Al	Si	Mn	Fe	Ag
Spectrum1	11.201	4.620	82.617			0.273	1.289
Spectrum2	9.574	4.091	84.491			0.263	1.581
Spectrum3	9.304	4.057	84.568			0.376	1.695
Spectrum4	9.701	4.175	84.162			0.309	1.653
Spectrum5	10.116	4.106	84.030			0.213	1.536
Spectrum6	10.169	4.082	83.713			0.192	1.843
Inclusion 1	11.948	3.838	76.464	0.360	0.431	5.043	1.916
